## Update "With-Site-Visit" Reserve Study

### Copper Creek Association Oro Valley, Arizona

Report #: 8141-3  
For Period Beginning: January 1, 2009  
Ending: December 31, 2009

Date Prepared: December 11, 2008

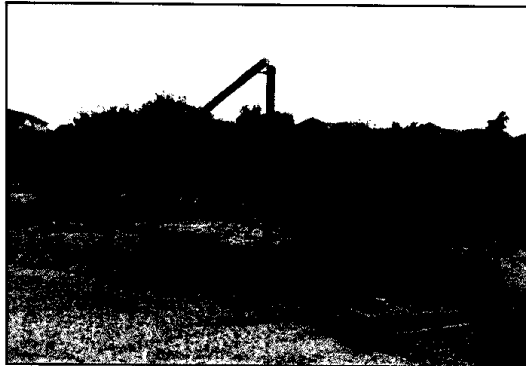
**Comp #:** 415 Exercise Stations - Replace

Evaluation: The exercise stations appear old and worn. Some vandalism noted. The association reports the stations will not be replaced when they are finally deemed unusable. No Reserve funding has been allocated to replace any of the exercise stations.

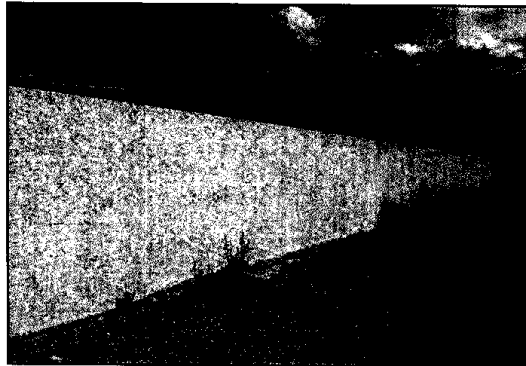
**Comp #:** 501 Stucco Walls - Repair

Evaluation: Walls vary in age and condition. There is no expectancy for widespread replacement under normal circumstances. A section collapsed and had to be rebuilt during 1999. This component provides an allowance to periodically repair or rebuild portions of the walls.

\$9.50/Sq Ft; Allowance to replace 1% of the total

\$11.50/Sq Ft; Higher allowance to replace 1%

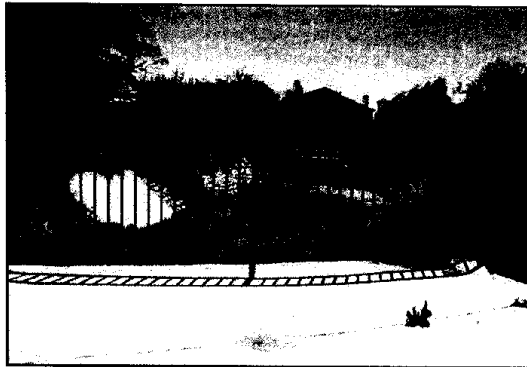
**Comp #:** 504 Iron Fence (Run-off) - Replace

Evaluation: Fence appears intact and in fair condition. Some rust evident. These fence sections need to properly maintained and not neglected for liability and safety issues. Future replacement should be anticipated.

\$33.00/LF; Estimate to replace

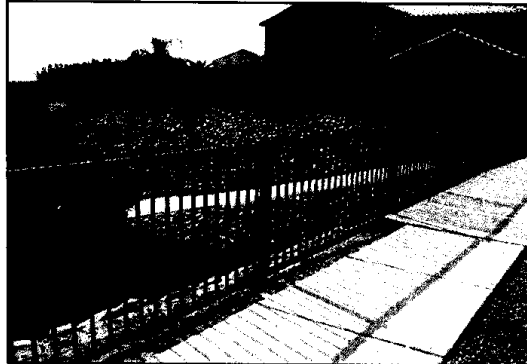
**Comp #:** 505 Iron Fence (Sump) - Replace

Evaluation: Fences are still solidly mounted and structurally intact. Some rust noted. These fence sections need to properly maintained and not neglected for liability and safety issues. Future replacement should be anticipated.

\$30.00/LF; Estimate to replace

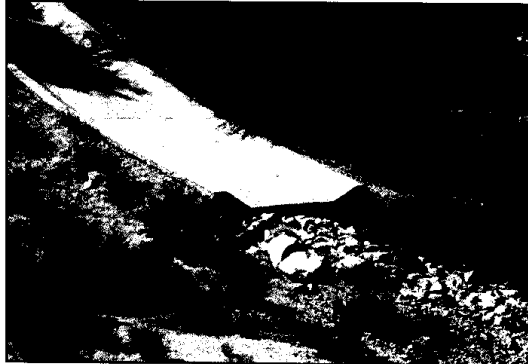
**Comp #:** 1008 Erosion Damage - Repair

Evaluation: Some of the spillways, especially off of Naranja, experience erosion damage after monsoon storms. This component provides an allowance for periodic repairs.

Best Case: \$1,200.00  
Allowance for repairs

Worst Case: \$1,500.00  
Higher allowance
