## Update "With-Site-Visit" Reserve Study

### Copper Creek Association Oro Valley, Arizona

Report #: 8141-3  
For Period Beginning: January 1, 2009  
Ending: December 31, 2009

Date Prepared: December 11, 2008

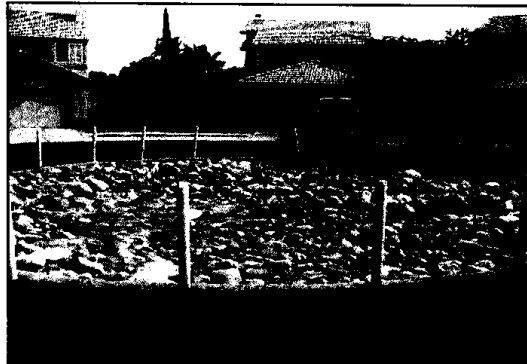
Remaining Life:  
0 years

Best Case: \$10,000.00

Estimate to resize

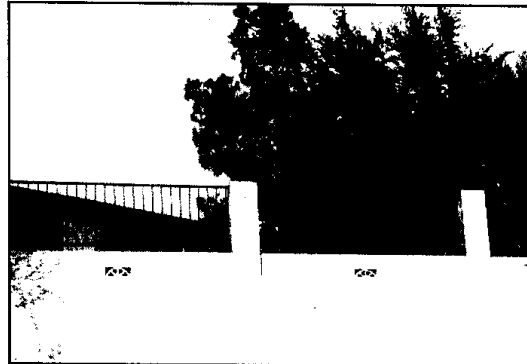
Useful Life:  
4 years

Remaining Life:  
1 years

Best Case: \$5,930.00

\$2.25/LF; Estimate to repaint, reflects 50% of the cost

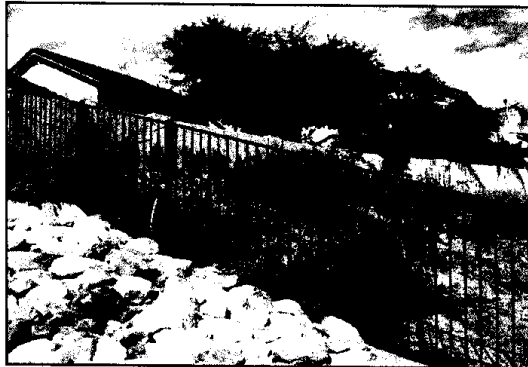
Useful Life:  
4 years

Remaining Life:  
2 years

Best Case: \$1,940.00

\$2.25/LF; Estimate to repaint

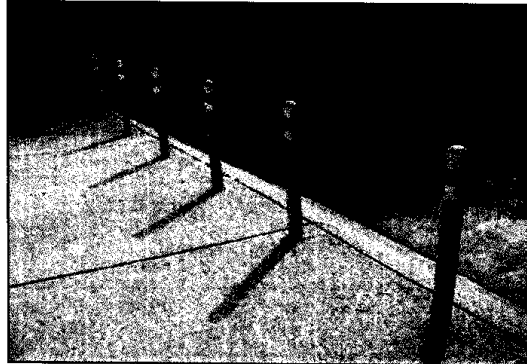
Useful Life:  
6 years

Remaining Life:  
1 years

Best Case: \$700.00  
\$5.00/Bollard; Estimate to repaint

Worst Case: \$900.00  
\$6.50/Bollard; Higher estimate

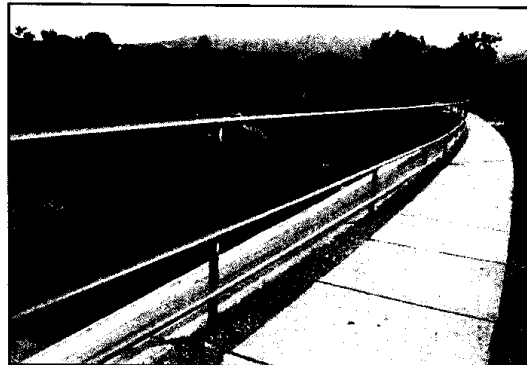
Useful Life:  
6 years

Remaining Life:  
3 years

Best Case: \$4,200.00  
\$4.00/LF; Estimate to repaint

Worst Case: \$5,250.00  
\$5.00/LF; Higher estimate

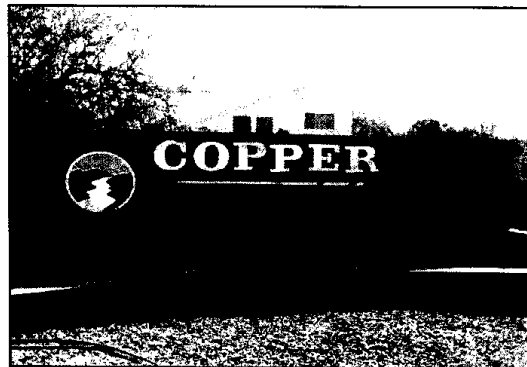
Useful Life:  
15 years

Remaining Life:  
1 years

Best Case: \$11,200.00

Allowance to refurbish monuments

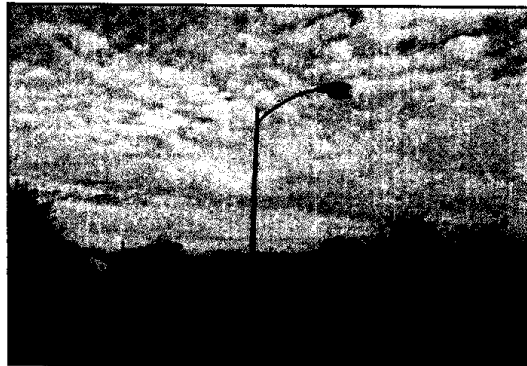
Useful Life:  
25 years

Remaining Life:  
13 years

Best Case: \$4,000.00

\$2,000/Light; Estimate to replace
